CONNECTICUT
DEPARTMENT
OF
TRANSPORTATION

CONDITION INSPECTION
FOR THE
GLENBROOK STATION

**CONN. DEPT OF TRANSPORTATION
STATION INSPECTION**

STATION: Glenbrook
LINE: New Canaan
INSPECTION DATE: 1/26/02
INSPECTION AGENCY / FIRM: UA
INSPECTORS: SS, RGW
WEATHER: Sunny, 40's

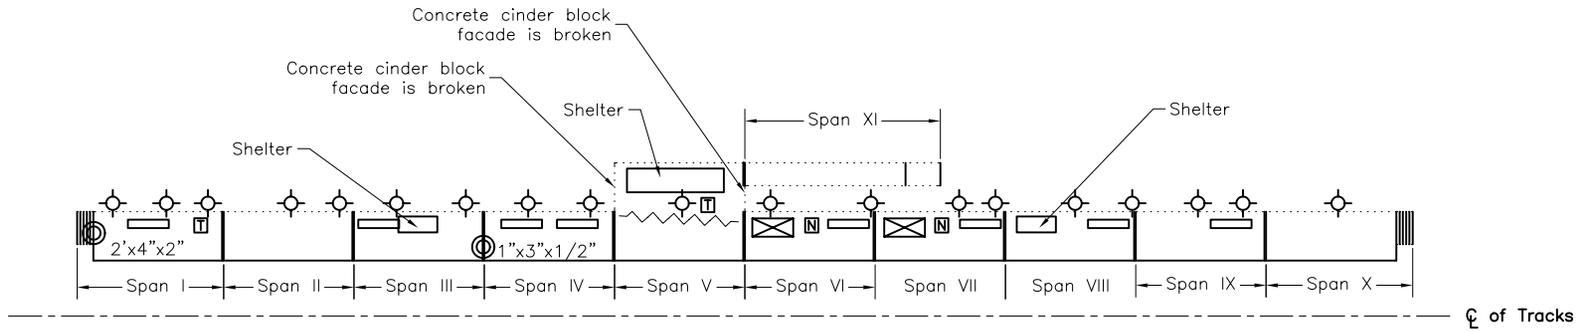
Urbitran Associates, Inc.
Connecticut Dept. of Transportation
Glenbrook Station Platform Plan
Date: 2/28/02

1. Typically the top of the concrete footings are spalled (upto 1'x3"x6") and the base plates are rusted and deteriorated.
2. The railing base plates are rusted and deteriorated.
3. The railing is bent in numerous areas.

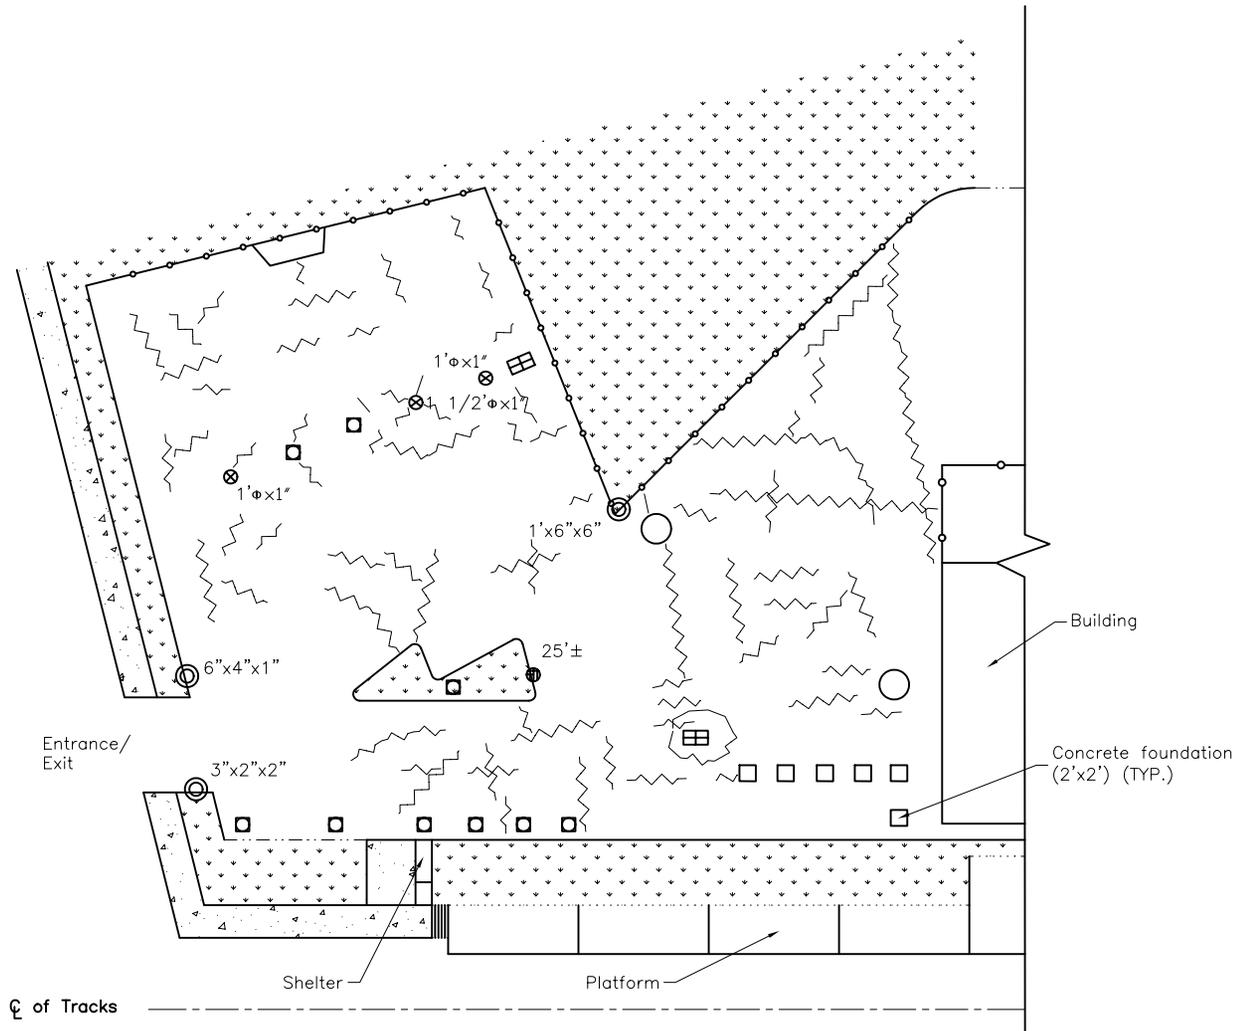
Urbitran Associates, Inc.
Connecticut Dept. of Transportation
Glenbrook Station Quadrant I Plan
Date: 2-28-02

1. 50% of the asphalt pavement is cracked.

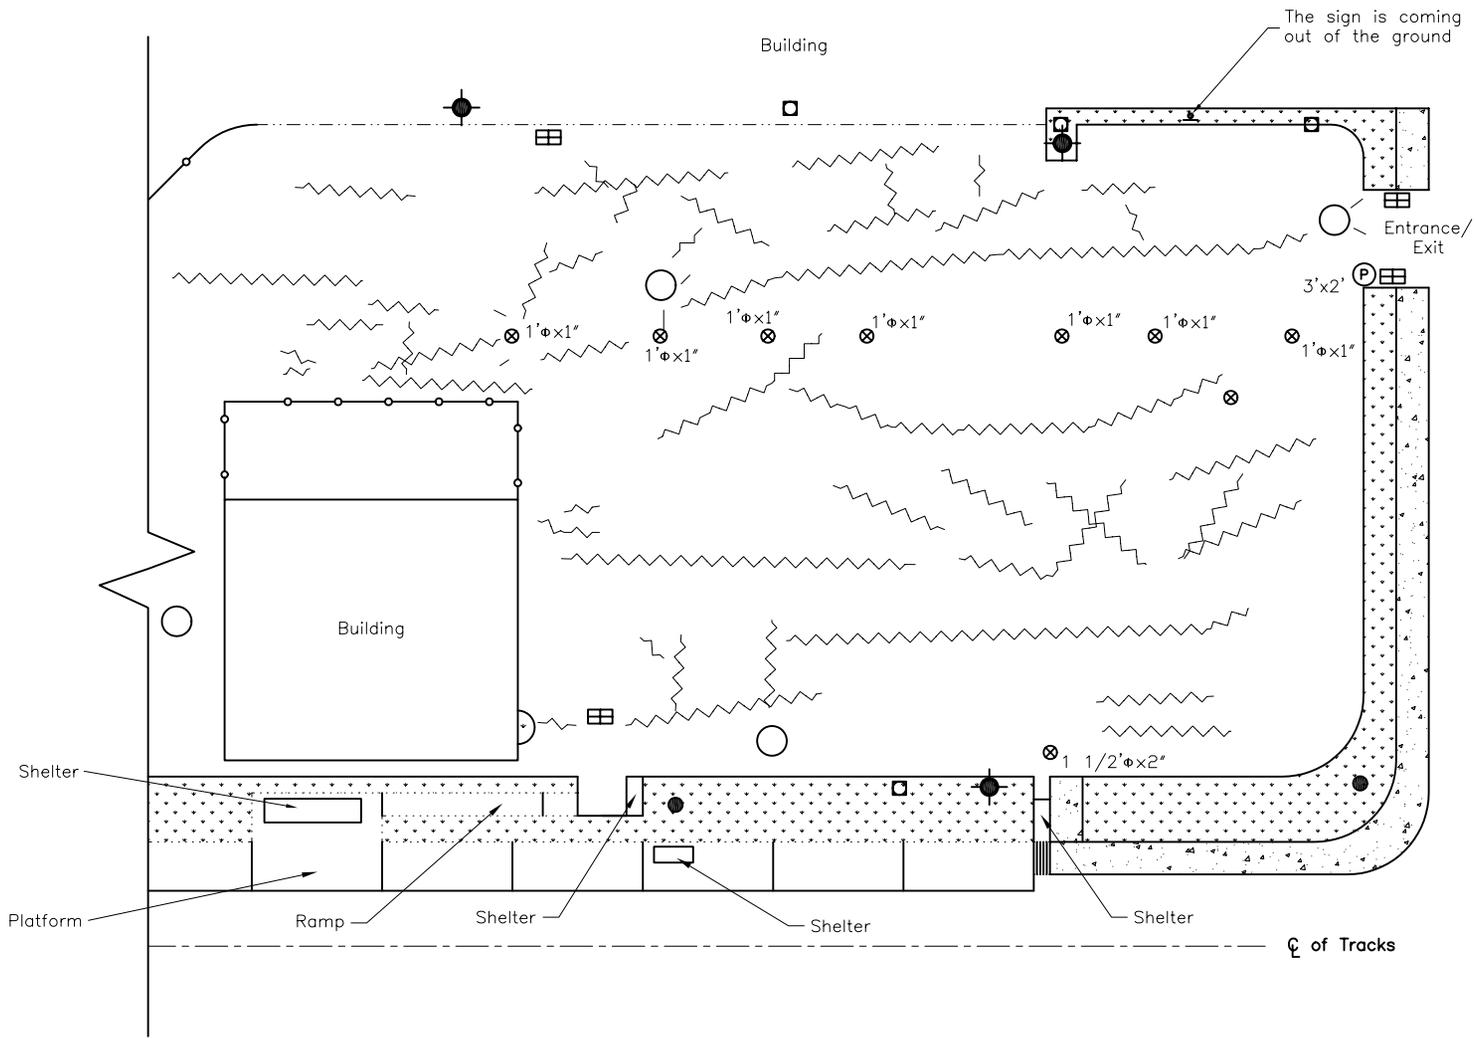
Urbitran Associates, Inc.
Connecticut Dept. of Transportation
Glenbrook Station Quadrant II Plan
Date: 2/28/02

1. 25% of the asphalt surface is cracked.

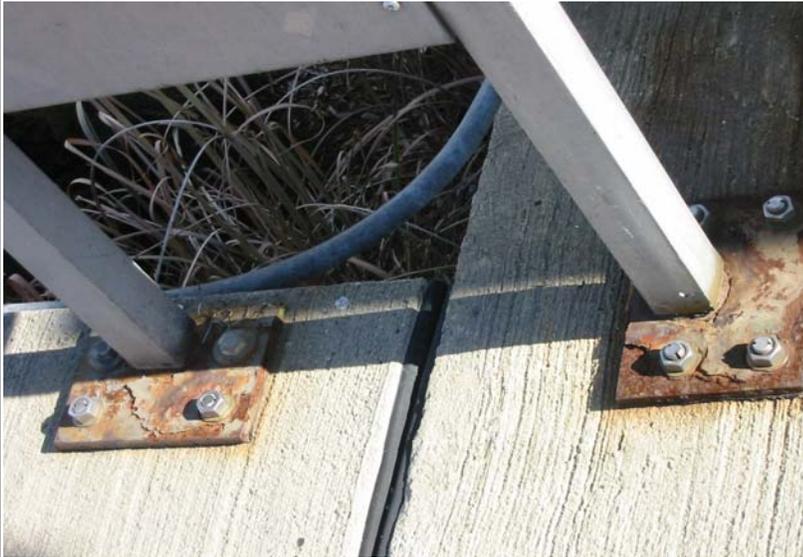
PHOTO NO. 10

Location: Between Span IV and V

Description: The railing base plates are rusted and deteriorated

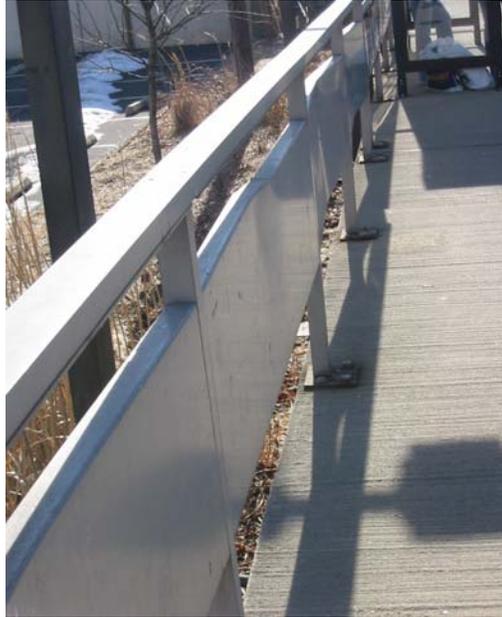
PHOTO NO. 11

Location: _____
West end of Span II

Description: _____
Typical bent railing

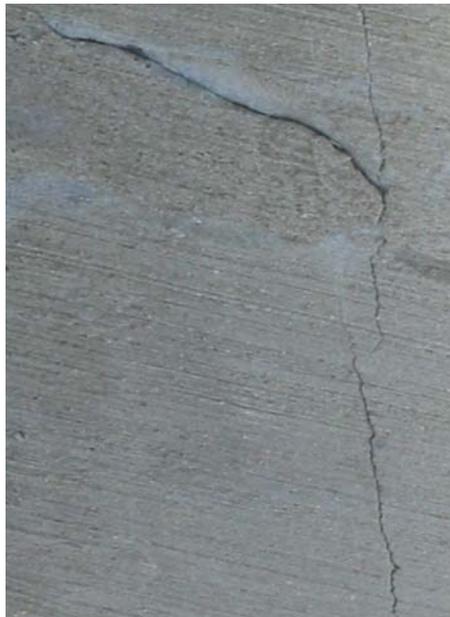
PHOTO NO. 12

Location: _____
Span V

Description: _____
Crack (40')

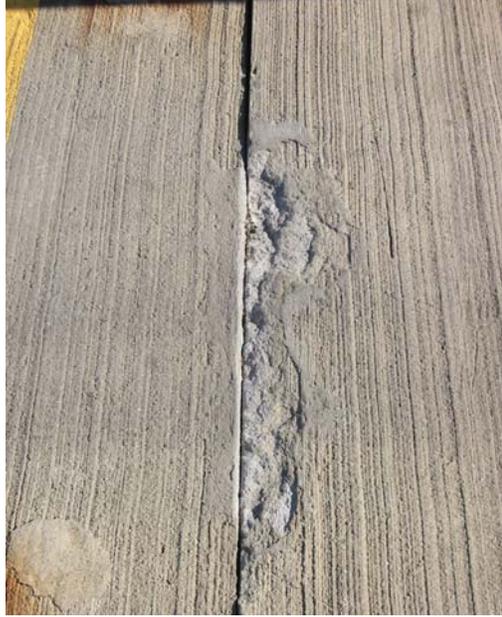
PHOTO NO. 13

Location: Between the stairs and the platform in Span I

Description: Spalled concrete
2'x4"x2"

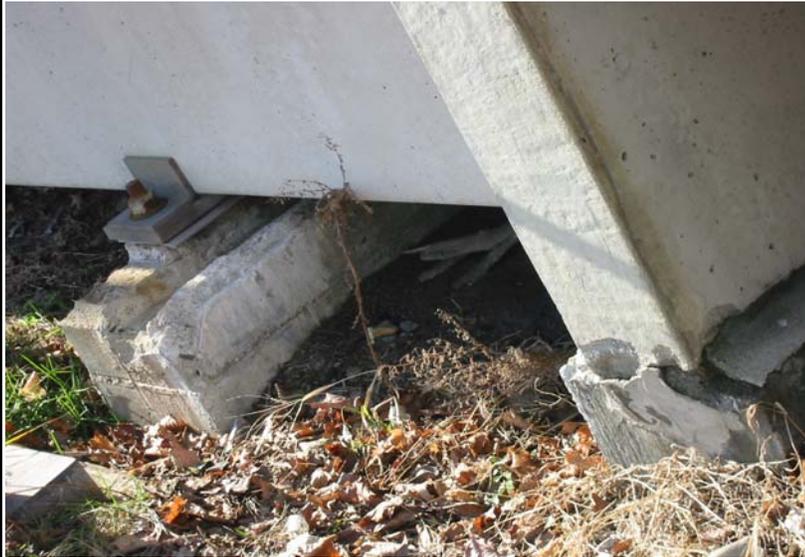
PHOTO NO. 14

Location: North of the west end of the platform

Description: Spalled concrete footing
(1'x3'x6");

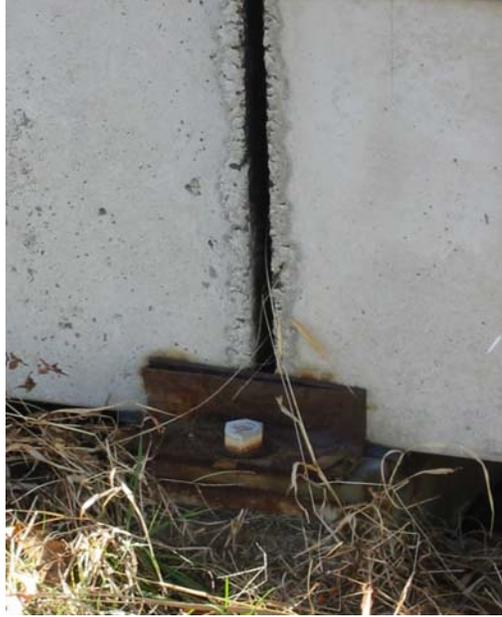
PHOTO NO. 15

Location: _____
North of the platform
between Span II and III

Description: _____
The base plate is rusted
and deteriorated.

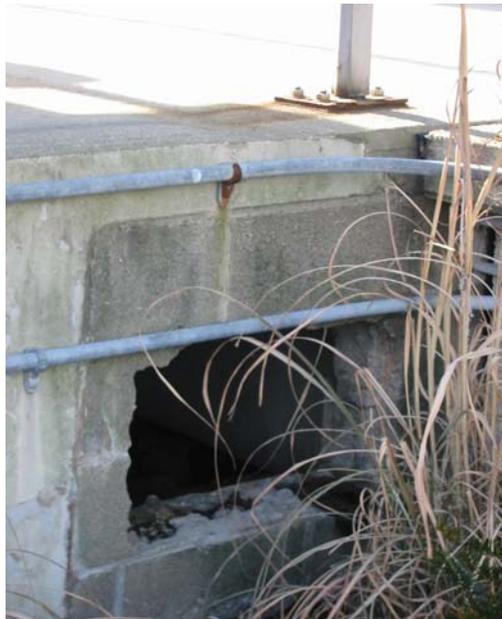
PHOTO NO. 16

Location: _____
West of span V

Description: _____
Damaged cinder block
façade (2'x2')

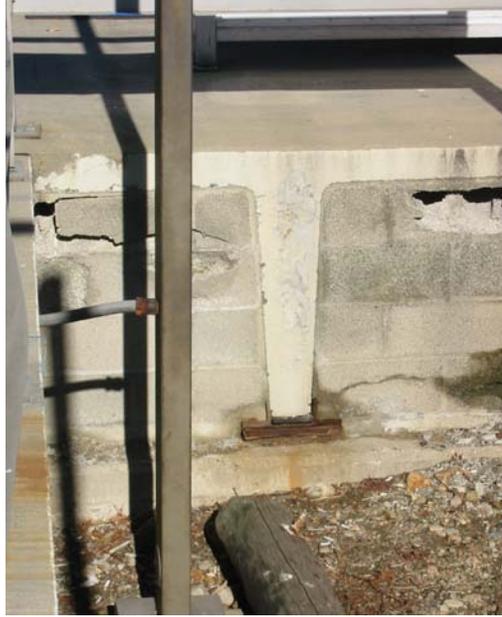
PHOTO NO. 17

Location: _____
East of Span V

Description: _____
Damaged cinder block
façade (2'x1')

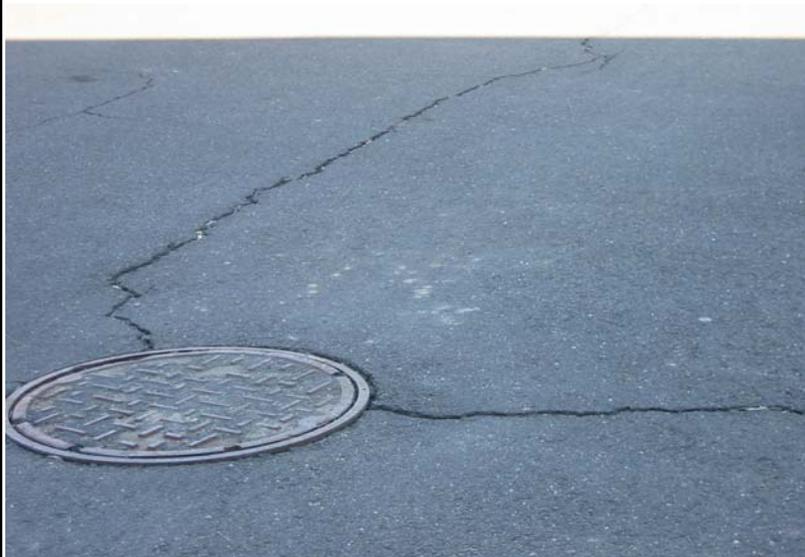
PHOTO NO. 18

Location: _____
East side of Quad I

Description: _____
Typical cracks in the
asphalt pavement

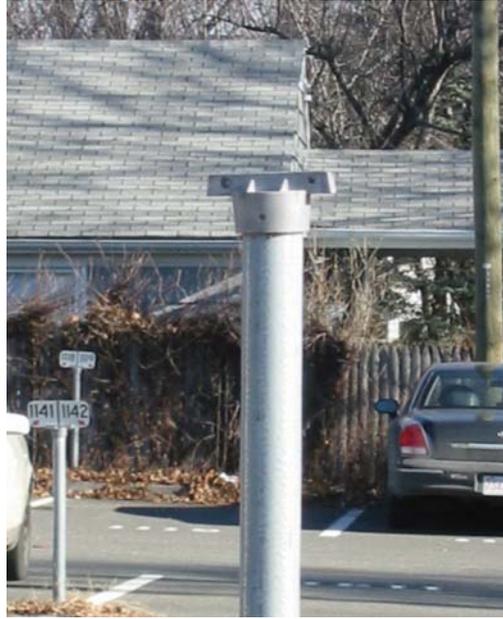
PHOTO NO. 19

Location: Middle of Quad I

Description: Typical pole with missing sign

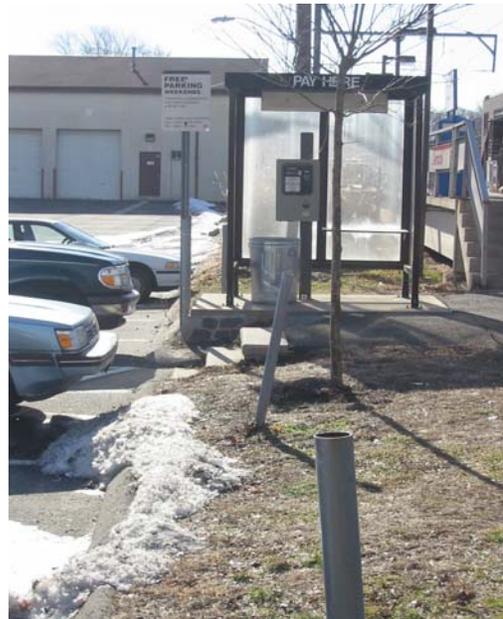
PHOTO NO. 20

Location: Southwest corner of Quad I

Description: The poles are leaning and or missing their sign

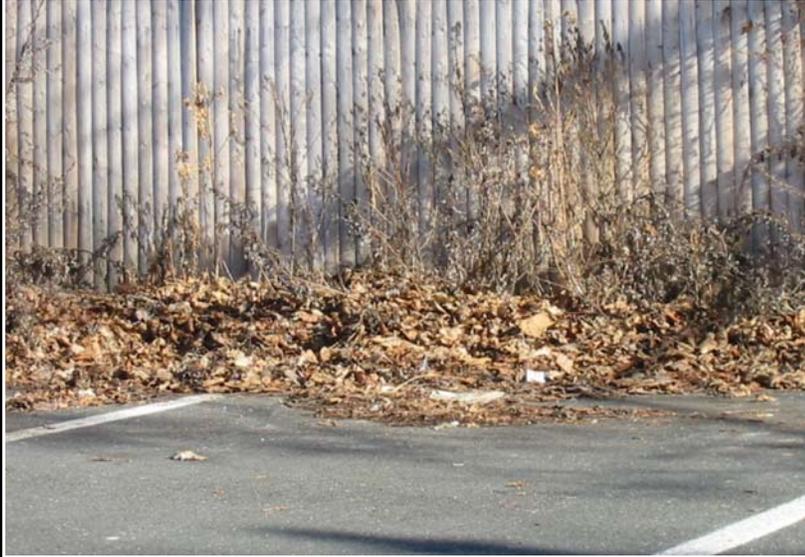
PHOTO NO. 21

Location: _____
North side of Quad I

Description: _____
Typical accumulation
of leaves in the parking
area

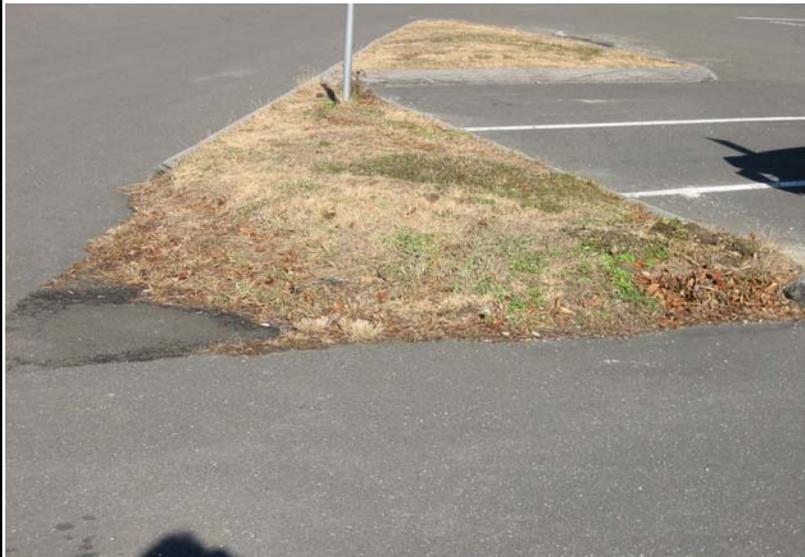
PHOTO NO. 22

Location: _____
Middle of Quad I

Description: _____
Missing asphalt curb

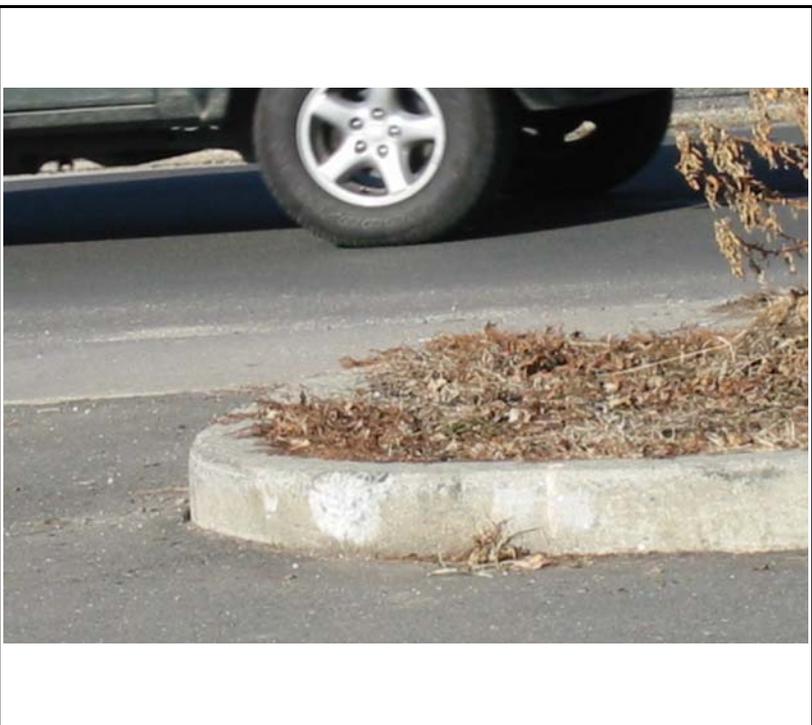
PHOTO NO. 23

Location: West entrance

Description: Spalled concrete curb
(6"x4"x1")

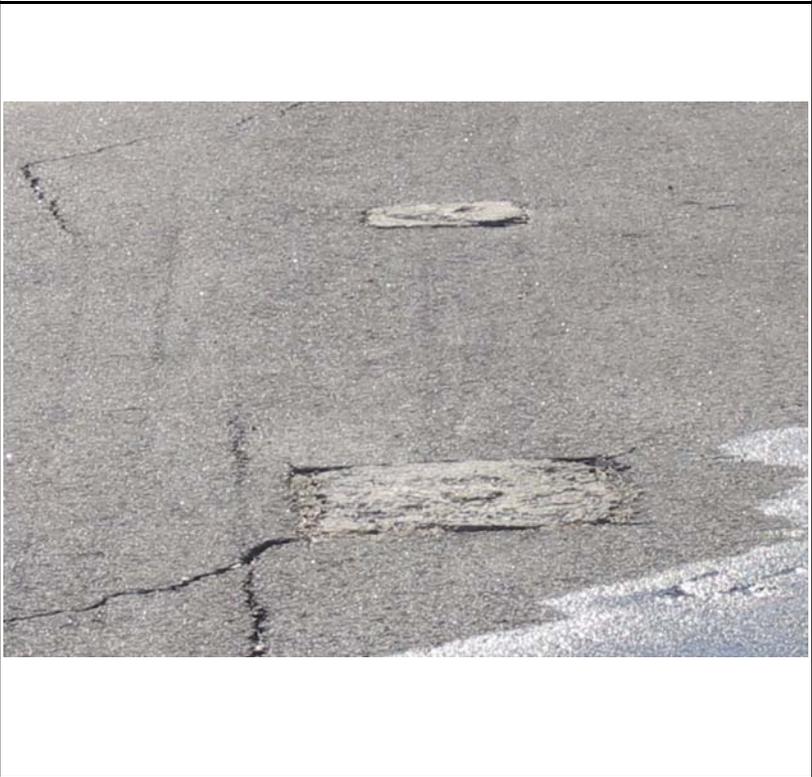
PHOTO NO. 24

Location: Southeast corner of
Quad I

Description: Abandoned concrete
footing that is uneven
with the asphalt
pavement (1"±)

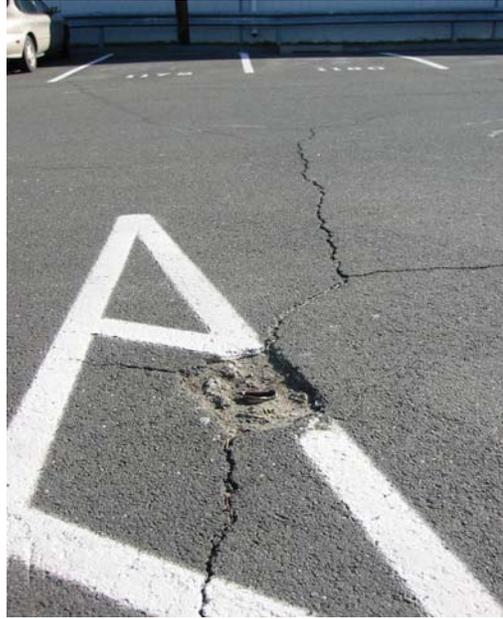
PHOTO NO. 25

2		25	Quad II Surface - There are numerous potholes (1'x1'x1") adjacent to abandoned poles.
2		26	Quad II Surface - Ponding of water was noted
2		28	Quad II Signage - The signs are missing and/or leaning.
2		27	Quad II Signage - One of the signs is coming out of the ground

Location: Middle of Quad II

Description: Pothole (1'x1'x1")
with corner cracks
adjacent to the
abandoned pole

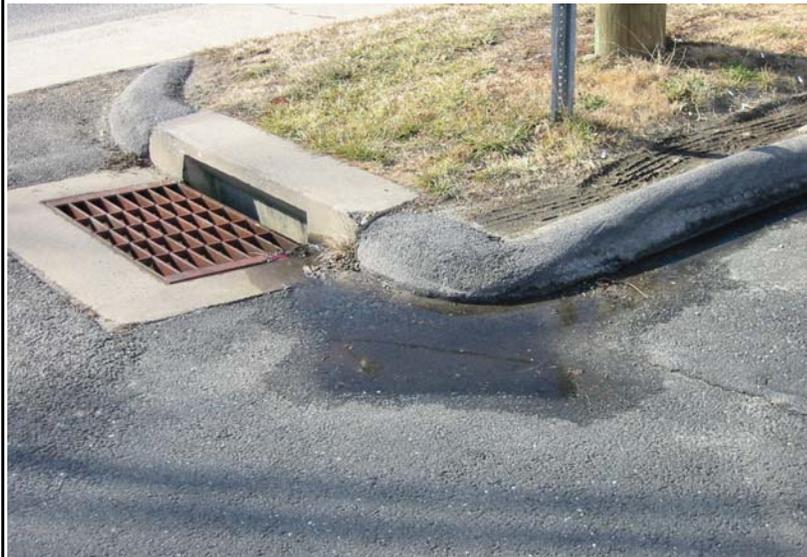
PHOTO NO. 26

Location: East side of Quad II

Description: Ponding of water (3'x2')

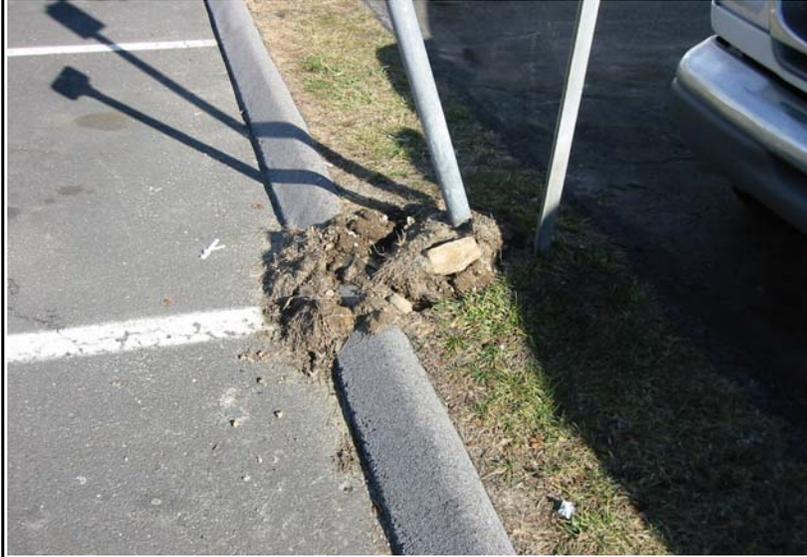
PHOTO NO. 27

Location: Northside of Quad II

Description: Upheaving sign

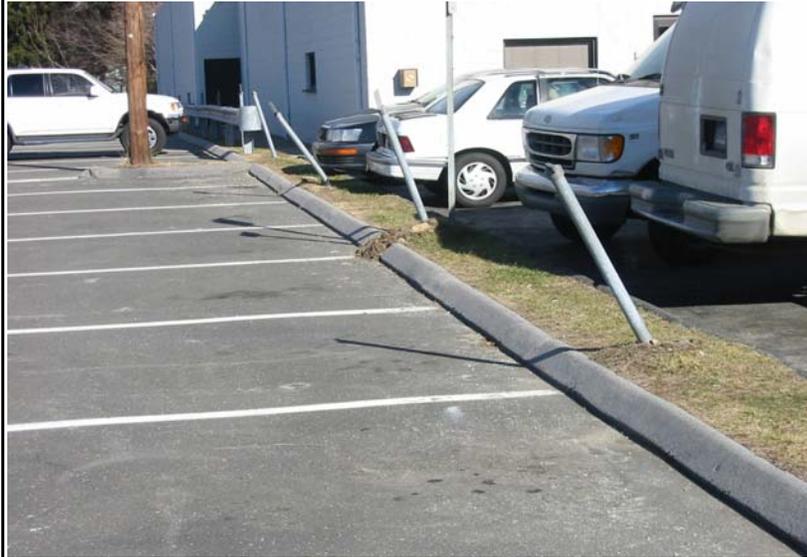
PHOTO NO. 28

Location: Northeast corner of Quad II

Description: Leaning sign posts

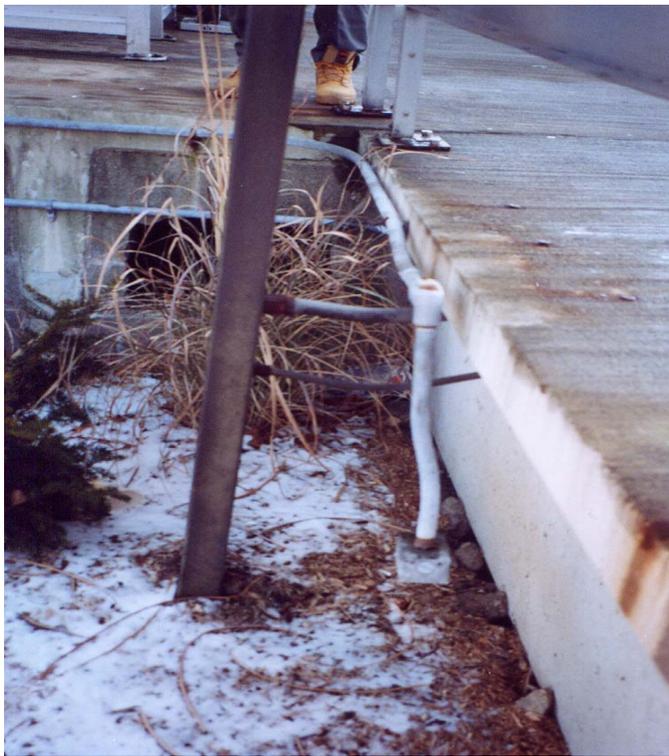
PHOTO NO. 32

Remarks: We found one receptacle that was not properly mounted and should be replaced.

Location:
platform

Description:
a receptacle
that needs to
be reattached to
the platform

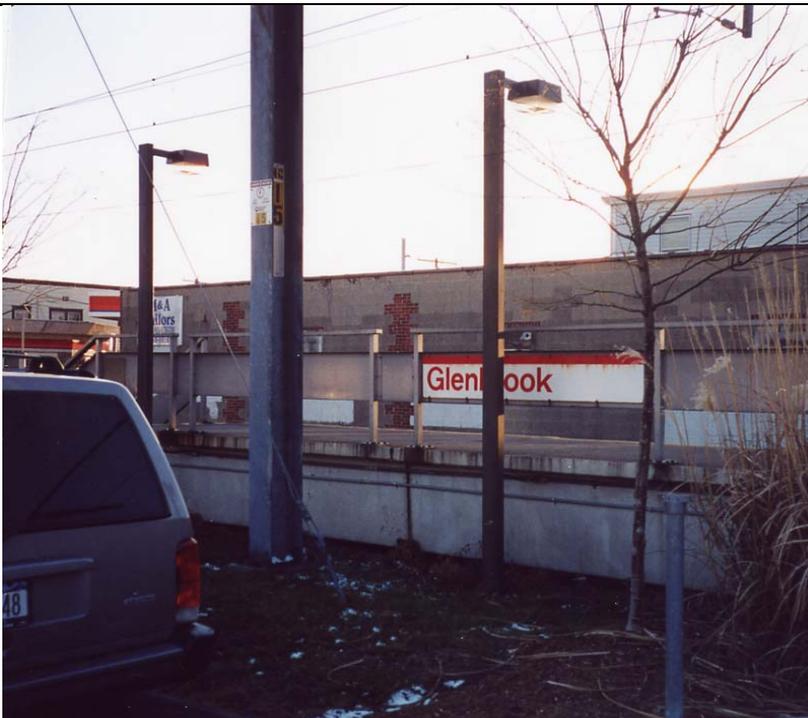
PHOTO NO. 33

Description:
Name of
station, slightly
obstructed

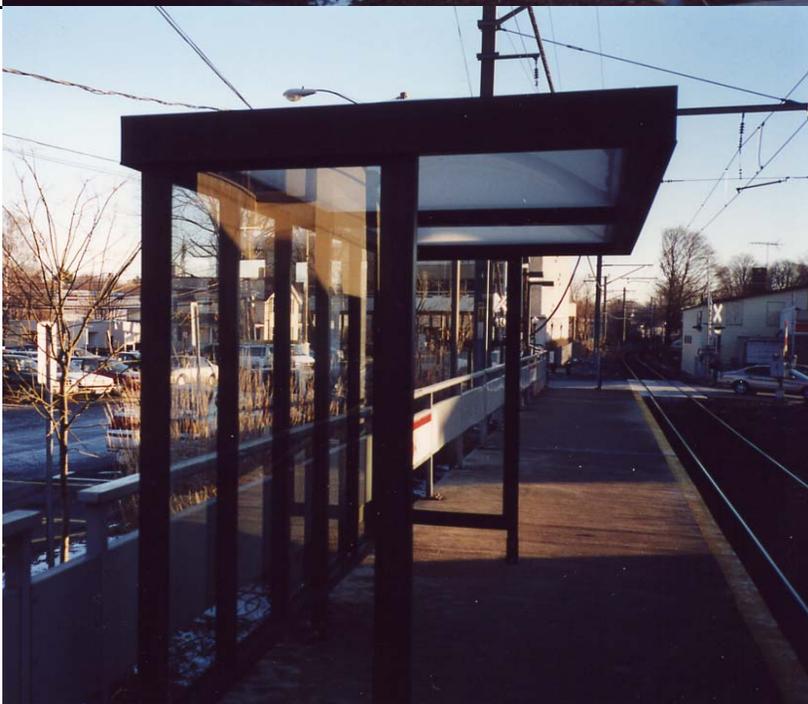
PHOTO NO. 34

Description:
Platform shelter
with plastic, round,
curbed roof, no drainage
system.
